CASE STUDY

Infiltrator Products Used in Residential System Installation on Remote Island

Farm Island, MN

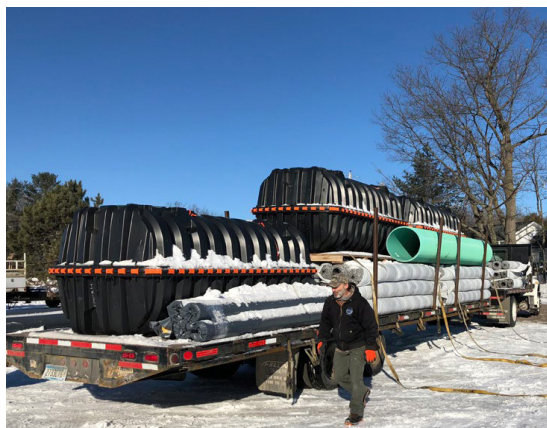
Equipment and supplies were driven across the frozen lake on a trailer and technicians commuted by snowmobile. An auger was used regularly to bore holes to check the thickness and quality of the ice and ensure safety.

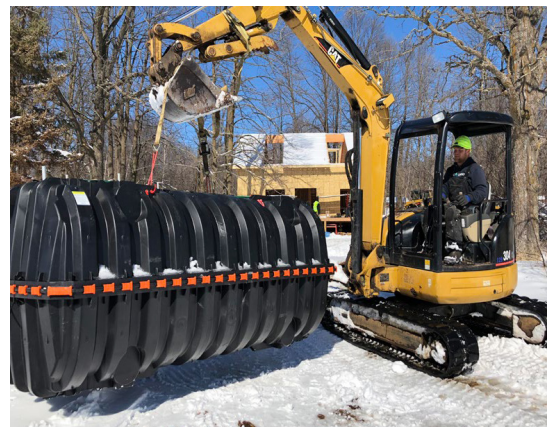
The wastewater treatment system is 250 feet from the lakeshore. Wastewater exits the house via 12 feet of PVC pipe to the first of three Infiltrator IM-1060 1,000-gallon tanks, where settling and anaerobic treatment occurs. Wastewater then flows by gravity into the second tank where a ECOPOD E50 ATU provides aerobic processing. It leaves the ECOPOD and flows by gravity through a SALCOR UV light to the last Infiltrator tank and is then pumped 65 feet through a 2-inch pipe to the absorption field. The 585-square foot absorption field uses 200 linear feet of EZflow by Infiltrator geosynthetic aggregate divided into three beds fed by a manifold of 2-inch pipe. Varying bed sizes maximized the small patch of good soil available on the one-acre lot. The system is controlled by an Infiltrator CPR52RCT15SUV control panel.
