## CASE STUDY

# EZflow Used in System with High Water Table and Limited Space

## Goddard, KS

450 GPD LPP Wastewater Treatment System

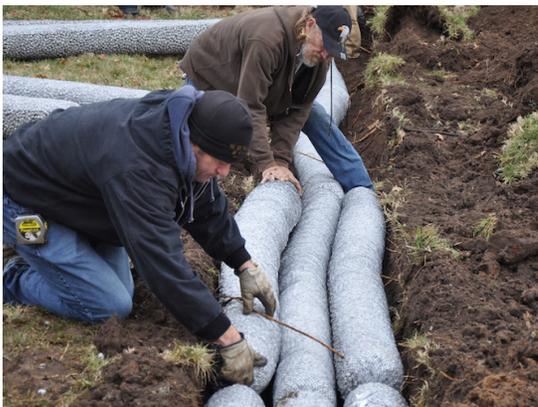
The 450 GPD replacement system includes five lines of EZflow installed on 5-foot centers. Each line is 45-feet long. The LPP lines are installed 8-inches deep to maintain more than two feet of separation from the limiting layer or water table at four feet.

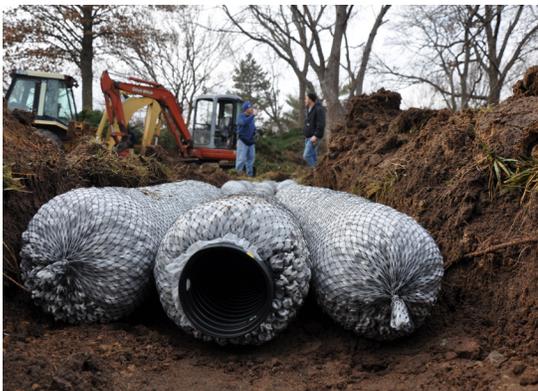
Everyone on the project was happy to get a system installed that could handle the needed flow in such a small area. There were no treatment units required and very little backfill needed.
